INDIANA DAM SAFETY INSPECTION MANUAL

UPDATED 2007

PART 3 DAM SAFETY INSPECTIONS

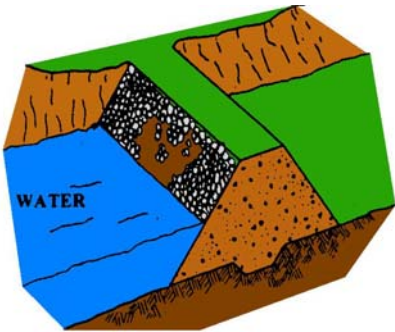
PROBLEMS	CAUSES & HARM DONE	ACTION REQUIRED
<p>BROKEN DOWN, MISSING RIPRAP</p>

<p>Probable Cause:</p> <p>Poor quality riprap has deteriorated. Wave action or ice action has displaced riprap. Round and similar sized rocks have rolled downhill.</p> <p>Harm:</p> <p>Wave action against these unprotected areas decreases embankment width.</p>	<p>Potential Action:</p> <p>Re-establish normal slope. Place bedding and competent riprap.</p>
<p>EROSION BEHIND POORLY GRADED RIPRAP</p>

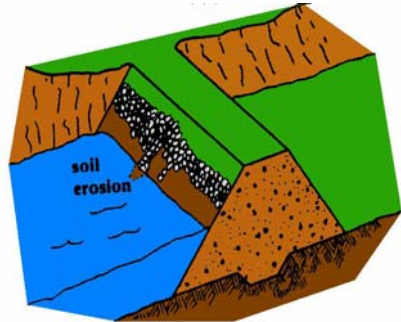
<p>Probable Cause:</p> <p>Similar-sized rocks allow waves to pass between them and erode small gravel particles and soil.</p> <p>Harm:</p> <p>Soil is eroded away from behind the riprap. This allows riprap to settle, providing less protection and decreased embankment width.</p>	<p>Potential Action:</p> <p>Re-establish effective slope protection. Place bedding material. ENGINEER REQUIRED for design of gradation and size of rock for bedding and riprap.</p> <p>A qualified engineer should inspect the conditions and recommend further actions to be taken.</p> <p><i>Qualified Dam Safety Professional Required</i></p>

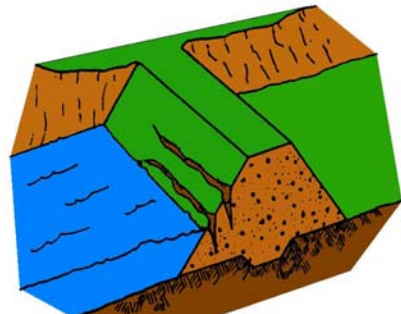
<p>LARGE CRACKS ON SLOPE</p>

<p>Probable Cause:</p> <p>A portion of the embankment has moved due to loss of strength, or the foundation may have moved, causing embankment movement.</p> <p>Harm:</p> <p>Can lead to failure of the dam.</p>	<p>Potential Action:</p> <p>Depending on the amount of embankment involved, draw reservoir level down. A qualified engineer should inspect the conditions and recommend further actions to be taken.</p> <p><i>Qualified Dam Safety Professional Required</i></p>

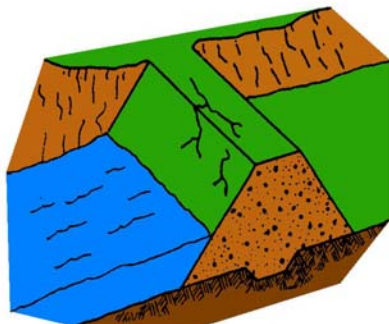
PROBLEMS**CAUSES & HARM DONE****ACTION REQUIRED****CRACKS DUE TO DRYING**

The soil loses its moisture and shrinks, causing cracks.

Heavy rains can fill up cracks and cause small portions of embankment to move along internal slip surface.

1. Monitor cracks for increases in width, depth, or length.
2. A qualified engineer should inspect the condition and recommend further actions to be taken.

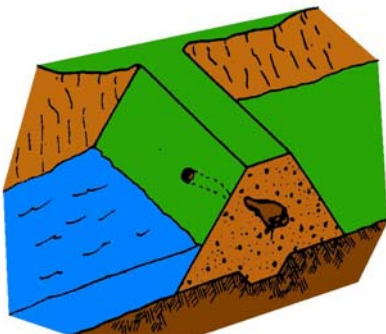
BEAVER OR MUSKRAT ACTIVITY

Holes, tunnels, and caverns are caused by animal burrows. Certain habitats like cattail-type plants and trees close to the reservoir encourage these animals.

If a tunnel exists through most of the dam, it can lead to failure of the dam.

Remove rodents. Determine exact location of digging and extent of tunneling. Remove habitat. Repair damages.

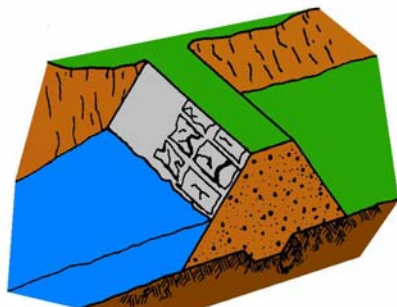
CRACKED DETERIORATED CONCRETE FACE

Concrete deteriorated due to weathering. Joint filler deteriorated or displaced.

Soil is eroded behind the face and caverns can be formed. Unsupported sections of concrete crack. Ice action may displace concrete.

1. Determine cause. Either patch with grout or contact engineer for permanent repair method.
2. If damage is extensive, a qualified engineer should inspect the conditions and recommend further actions to be taken.

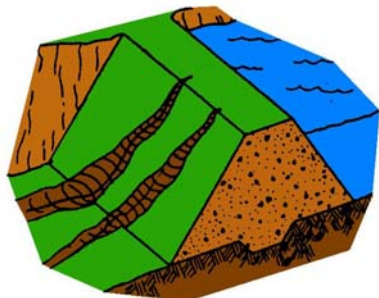
PROBLEMS**EROSION**

Water from intense rainstorms or snow-melt carries surface material down the slope, resulting in continuous troughs.

If allowed to continue, erosion can lead to eventual deterioration of the downstream slope which can shorten the seepage path.

1. The preferred method to protect eroded areas is rock or riprap.
2. Re-establishing protective grasses can be adequate if the problem is detected early.

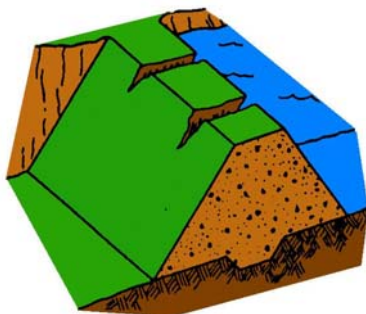
TRANSVERSE CRACKING AFFECTING SLOPE

1. Drying and shrinkage of surface material is most common.
2. Differential settlement of the embankment also leads to transverse cracking (e.g., center settles more than abutments).

1. Shrinkage cracks allow water to enter the embankment. This promotes saturation and increases freeze thaw action.
2. Settlement cracks can lead to seepage of reservoir water through the dam.
3. Can lead to uncontrolled breach.

1. If necessary plug upstream end of crack to prevent flows from the reservoir.
2. A qualified engineer should inspect the conditions and recommend further actions to be taken.

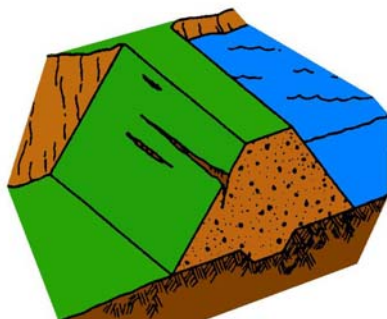
LONGITUDINAL CRACKING ON SLOPE

1. Drying and shrinkage of surface material.
2. Downstream movement or settlement of embankment.

1. Can be an early warning of a potential slide.
2. Shrinkage cracks allow water to enter the embankment and freezing will further crack the embankment.
3. Settlement or slide indicating loss of strength in embankment can lead to failure.

1. If cracks are from drying, dress area with well-compacted material to keep surface water out and natural moisture in.
2. If cracks are extensive, a qualified engineer should inspect the conditions and recommend further actions to be taken.

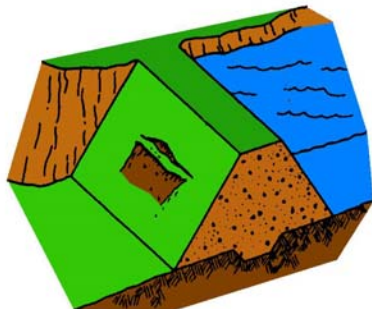
PROBLEMS**SLIDE/SLOUGH**

1. Lack of or loss of strength of embankment material.
2. Loss of strength can be attributed to infiltration of water into the embankment or loss of support by the foundation.

Can lead to failure of the dam.

1. Measure extent and displacement of slide.
2. If continued movement is seen, begin lowering water level until movement stops.
3. Have a qualified engineer inspect the condition and recommend further action.

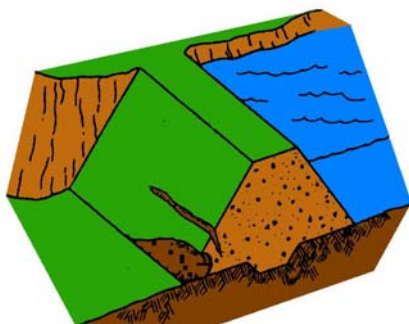
SLUMP (LOCALIZED CONDITION)

Preceded by erosion undercutting a portion of the slope. Can also be found on relatively steep slopes.

1. Inspect area for seepage.
2. Monitor for progressive failure.
3. Have a qualified engineer inspect the condition and recommend further action.

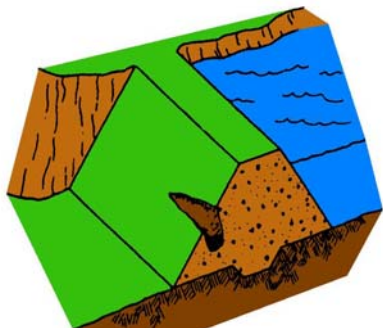
SINK HOLE/COLLAPSE

Lack of adequate compaction; rodent hole below; piping through embankment or foundation.

1. Inspect for and immediately repair rodent holes. Control rodents to prevent future damage.
2. Have a qualified engineer inspect the condition and recommend further action.

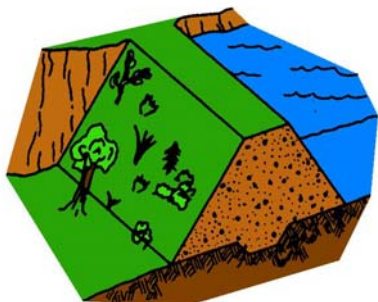
PROBLEMS**CAUSES & HARM DONE****ACTION REQUIRED****TREES/OBSCURING BRUSH**

Natural vegetation in area.

1. Remove all large, deep-rooted trees and shrubs on or near the embankment. Properly backfill void.
2. Control all other vegetation on the embankment that obscures visual inspection.

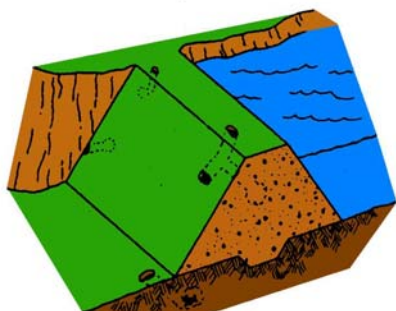
RODENT ACTIVITY ON SLOPE

Overabundance of rodents.

Reduces length of seepage path. Can lead to piping failure.

1. Control rodents to prevent additional damage.
2. Backfill existing rodent holes.

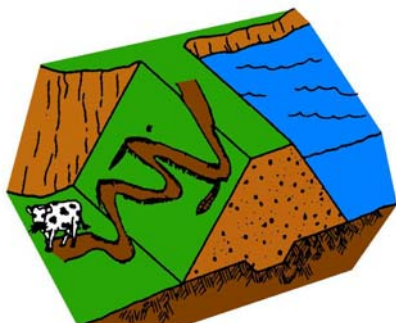
LIVESTOCK/CATTLE TRAFFIC

Excessive travel by livestock especially harmful to slope when wet.

Creates areas bare of erosion protection and causes erosion channels. Allows water to stand. Area susceptible to drying cracks.

1. Fence livestock outside embankment area.
2. Repair erosion protection, i.e., riprap, grass.

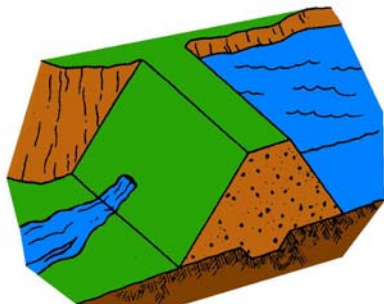
MUDDY WATER EXITING FROM A POINT SOURCE

1. Water has created an open pathway, channel, or pipe through the dam. The water is eroding and carrying embankment material.
2. Large amounts of water have accumulated in the downstream slope. Water and embankment materials are exiting at one point. Surface agitation may be causing the muddy water.

Continued flows can further erode embankment materials. This can lead to failure of the dam.

1. Begin measuring outflow quantity and establishing whether water is getting muddier, staying the same, or clearing up.
2. If quantity of flow is increasing, the water level in the reservoir should be lowered until the flow stabilizes or stops.
3. A qualified engineer should inspect the condition and recommend further actions to be taken.

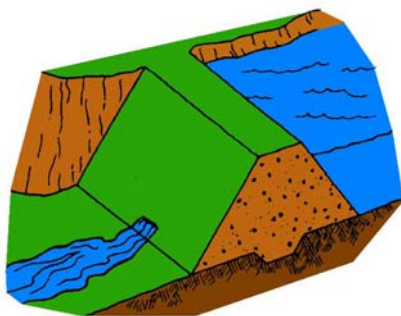
WATER EXITING FROM A POINT SOURCE

Water has created an open pathway or pipe through the dam.

Continued flows can further erode embankment materials. This can lead to failure of the dam.

1. Begin measuring outflow quantity.
2. If quantity of flow is increasing, the water level in the reservoir should be lowered until the flow stabilizes or stops.
3. A qualified engineer should inspect the condition and recommend further actions to be taken.

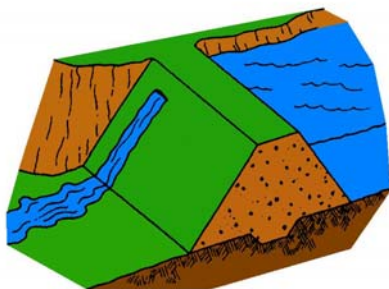
WATER EXITING FROM A POINT SOURCE HIGH ON THE EMBANKMENT

1. Rodents, frost action, or poor construction have allowed water to create an open pathway or pipe through the embankment.

1. Continued flows can saturate portions of the embankment and lead to slides in the area.
2. Continued flows can further erode embankment materials and lead to failure of the dam.

1. Begin measuring outflow quantity.
2. If quantity of flow is increasing, the water level in the reservoir needs to be lowered until the leak stops.
3. Search for opening on upstream side and plug it if possible.
4. A qualified engineer should immediately inspect the condition and recommend further action to be taken.

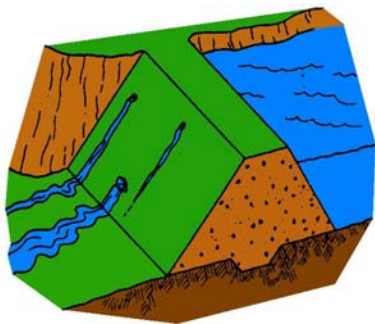
PROBLEMS**WATER EXITING FROM RODENT HOLES**

Diggings by the rodent have shortened the flow path.

Continued flows can further erode embankment material and lead to failure of the dam.

1. Locate any entrance points on the upstream slope and plug them.
2. If the quantity of flow is increasing, the water level in the reservoir needs to be lowered until the leak stops.
3. Bring a halt to the rodent activity.
4. A qualified engineer should inspect the condition and recommend further actions to be taken.

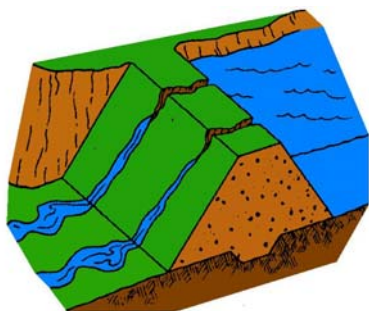
STREAM OF WATER EXITING THROUGH CRACKS NEAR THE CREST

1. Severe drying has caused shrinkage of embankment material.
2. Settlement in the embankment or foundation is causing the transverse cracks.

Flow through the crack can cause failure of the dam.

1. Plug the upstream side of the crack to stop the flow.
2. The water level in the reservoir should be lowered until it is below the level of the cracks.
3. A qualified engineer should inspect the condition and recommend further actions to be taken.

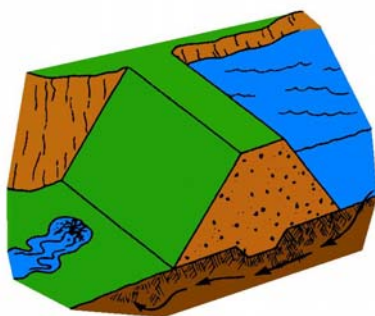
SEEPAGE WATER EXITING AS A BOIL IN THE FOUNDATION

Some portion of the foundation material is providing a flow path. This could be caused by a sand or gravel layer in the foundation.

Increased flows can lead to erosion of the foundation and failure of the dam.

1. Examine the boil for transportation of foundation materials.
2. If soil particles are moving downstream, sandbags or earth should be used to create a dike around the boil. The pressure created by the water level within the dike may control flow velocities and temporarily prevent further erosion. A graded filter may also be placed in the boil to inhibit soil loss.
3. If erosion is becoming greater, the reservoir level should be lowered.
4. A qualified engineer should inspect the condition and recommend further actions to be taken.

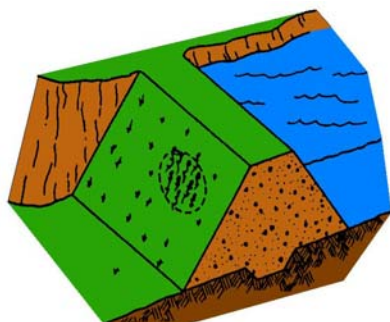
MARKED CHANGED IN VEGETATION

1. Embankment materials are providing flow paths.
2. Natural seeding by wind.
3. Change in seed type during initial post construction seeding.

1. Use probe or shovel to establish if the materials in this area are wetter than in surrounding areas.
2. If area shows wetness when surrounding areas do not, a qualified engineer should inspect the condition and recommend further actions to be taken.

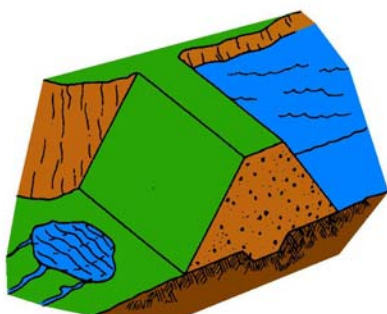
TRAMPOLINE EFFECT IN LARGE SOGGY AREA

Water moving rapidly through the embankment or foundation is being controlled or contained by a well-established turf root system.

Condition indicates excessive seepage in the area. If control layer of turf is destroyed, rapid erosion of foundation materials could result in failure of the dam.

1. Carefully inspect the area for outflow quantity and any transported materials.
2. A qualified engineer should inspect the condition and recommend further actions to be taken.

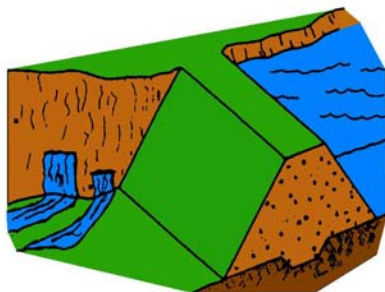
LEAKAGE FROM ABUTMENTS BEYOND THE DAM

Water moving through cracks and fissures in the abutment materials.

1. Carefully inspect the area to determine quantity of flow and amount of transported material.
2. A qualified engineer or geologist should inspect the condition and recommend further actions to be taken.

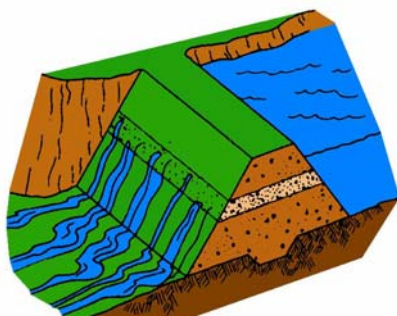
WET AREA IN HORIZONTAL BAND

Frost layer or layer of sandy material in original construction.

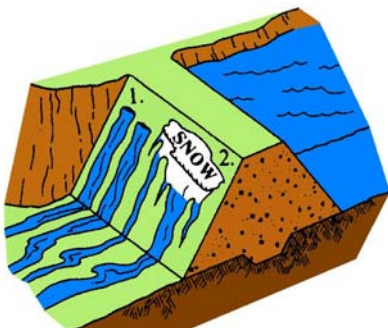
LARGE AREA SATURATED FROM ABOVE

1. Water flowing through the embankment.
2. Snowdrifts melting slowly during mild spring temperatures.

Can lead to saturation of embankment materials and local or massive slides which could cause failure of the dam.

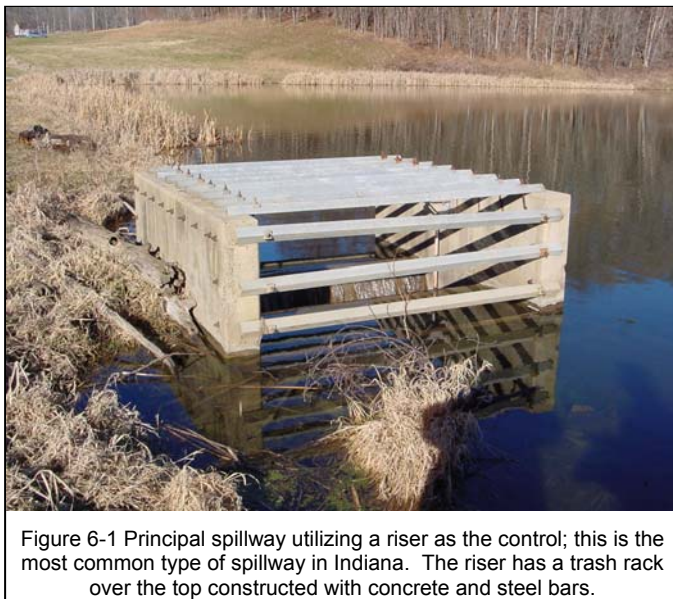
The spillway system consists of the structures over or through which base inflows and flood flows are safely discharged. If the flow is controlled by gates, it is a **controlled spillway**; if the elevation of the spillway crest is the only control, it is an **uncontrolled spillway**. Uncontrolled spillways are the most commonly used type in Indiana. Figure 6-1 shows an uncontrolled spillway; the control section is the crest of a riser pipe.

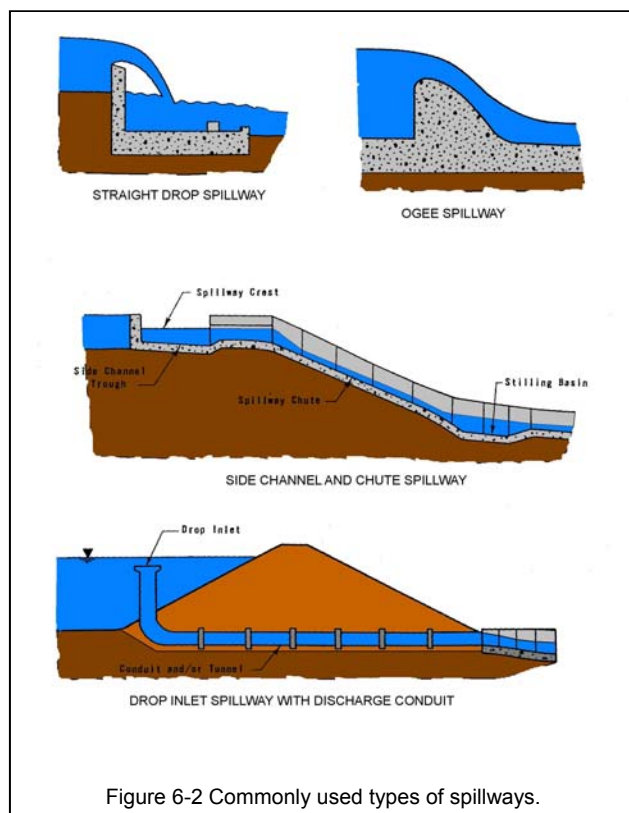
Drop Inlet Spillway (also called Morning Glory Spillway, or Shaft Spillway) - A vertical or inclined shaft into which flood water spills and then is conducted through, under, or around a dam by means of a conduit or tunnel. If the upper part of the shaft is splayed out and terminates in a circular horizontal weir, it is termed a "bellmouth" or "morning glory" spillway. The vertical portion of the spillway is called the **riser**. The risers are typically reinforced concrete pipes or boxes. Shaft spillways are commonly

Figure 6-2 Commonly used types of spillways.

The following types of spillways are commonly found at dams; however, many variations of these spillways may be used. Figure 6-2 illustrates some commonly used types of spillways. The most commonly used spillways used in Indiana include the drop inlet (or shaft) spillway used as the principal spillway, and an open channel used as the principal spillway or as an auxiliary, or emergency spillway.

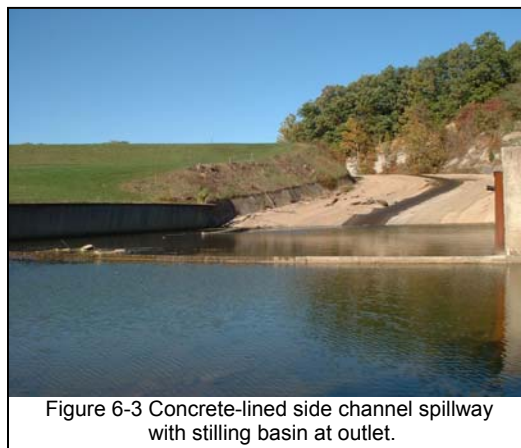
Side Channel Spillway - A spillway located on insitu ground to the side of the embankment. Emergency spillways are usually side channel spillways; however, principal spillways may also be side channel spillways. Side channels may be constructed with energy dissipation structures, such as baffles or stilling basins, to reduce discharge velocity and energy.

Figure 6-3 Concrete-lined side channel spillway with stilling basin at outlet.

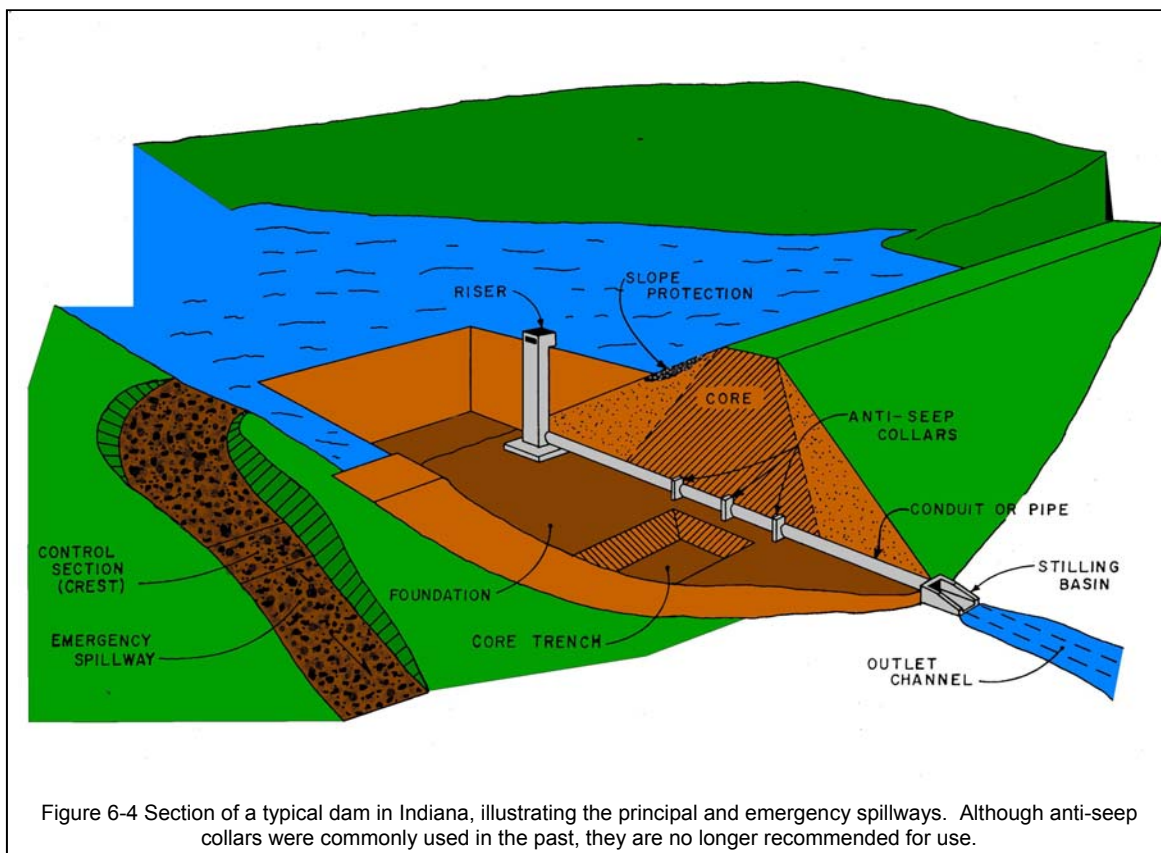
The outlet is the structure through which water can be freely discharged from a reservoir. Outlets are used to drawdown the reservoir level in dams, or to maintain a desired flow downstream of the dam. An outlet may also be referred to as a reservoir drain.

The primary function of the outlet (also called outlet works, or outlet system) is to provide for the controlled release of water from the reservoir behind the dam. The outlet system is used to release water downstream for irrigation, dam repairs, emergencies, and other uses. The size of the outlet system is determined by the rate of demand downstream, or the desired rate of drawdown that may be needed for maintenance. Except in an emergency, the rate of drawdown of the reservoir should be slow; not exceeding one foot per 24-hour period is typical. In an emergency, drawdown should be accomplished as rapidly as possible without creating additional peril to the dam, its appurtenances, or the area downstream.

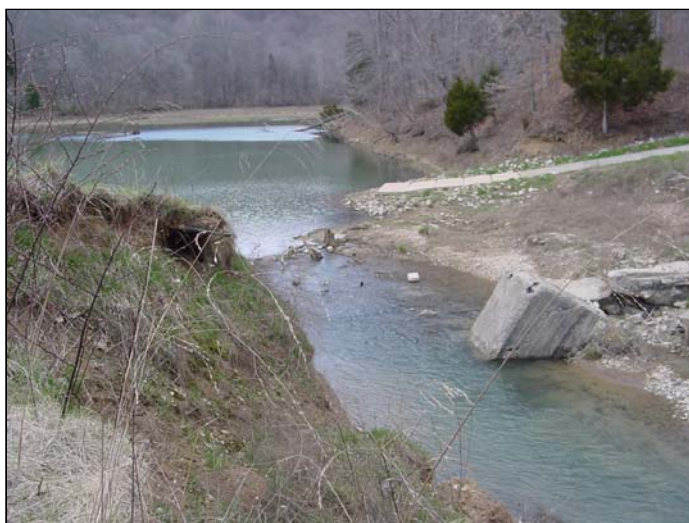
Figure 6-5 This dam's open channel spillway used a concrete control section; note that it failed and was almost totally washed away.

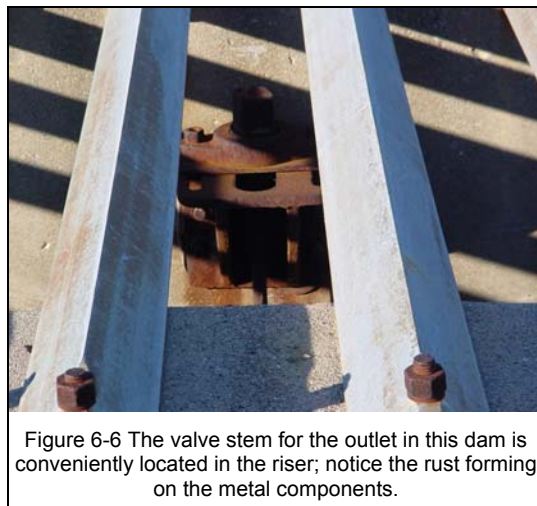
Figure 6-6 The valve stem for the outlet in this dam is conveniently located in the riser; notice the rust forming on the metal components.

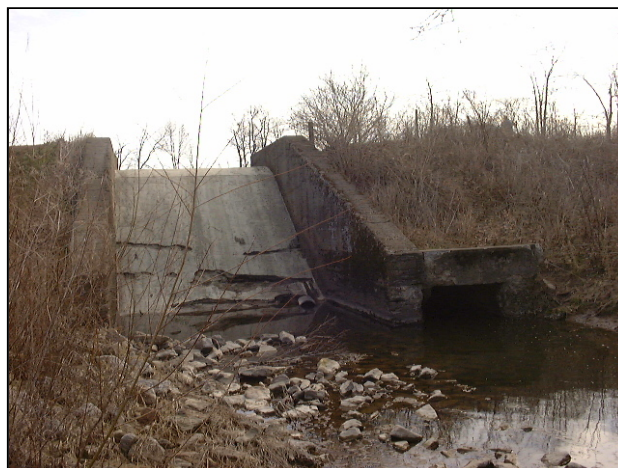
Figure 6-7 Concrete spillway showing extensive cracking and general deterioration, most likely a result of freeze-thaw effects.

Cracks are commonly encountered defects for concrete spillways; cracks are less common in outlets, although they still occur. Cracks may be caused by foundation problems, water pressure, concrete expansion, freeze-thaw effects, poor concrete mix design, poor construction practices, and chemical reactions. The discussion of cracks in this section applies to both spillways and outlets. The open, concrete spillway in Figure 6-7 has extensive cracking and deterioration and should be repaired immediately.

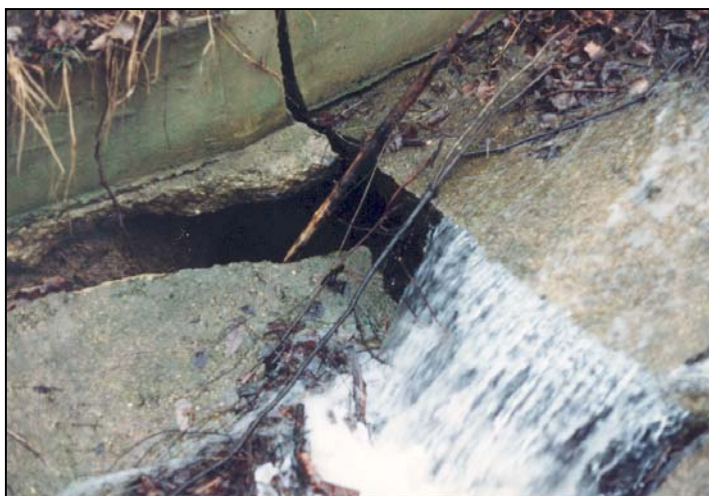
Figure 6-8 Concrete spillway with structure damage.

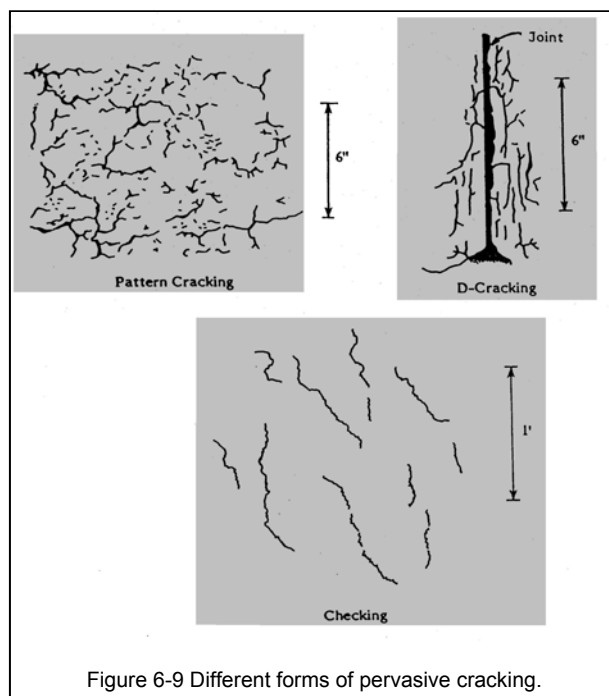
The inspector should be especially alert for thermal cracking in the massive concrete monoliths of concrete structures or dams. A pattern of hairline cracks in an orthogonal, blocky "dried mud puddle" configuration inside of galleries, usually accompanied by considerable leakage, is a sign of thermal cracking. Another sign of thermal cracking is the presence of vertical cracks continuous through walls, ceilings, and floors of transverse galleries resulting from cooling of concrete and restraint near the foundation. If thermal cracking is suspected, installing temperature gages for temperature studies provides a means to collect relevant data.

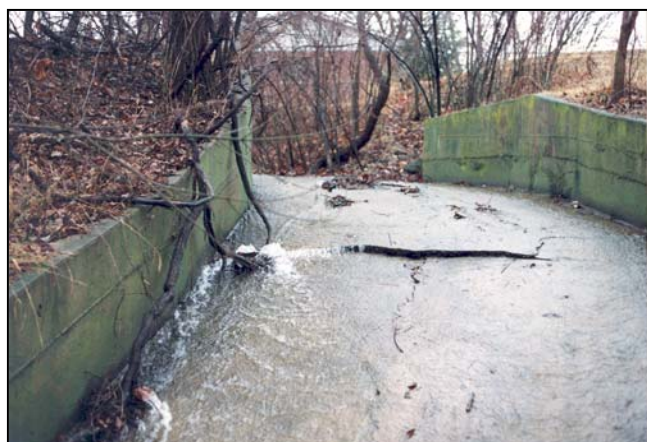
Figure 6-11 Large structural cracks with vertical displacement.

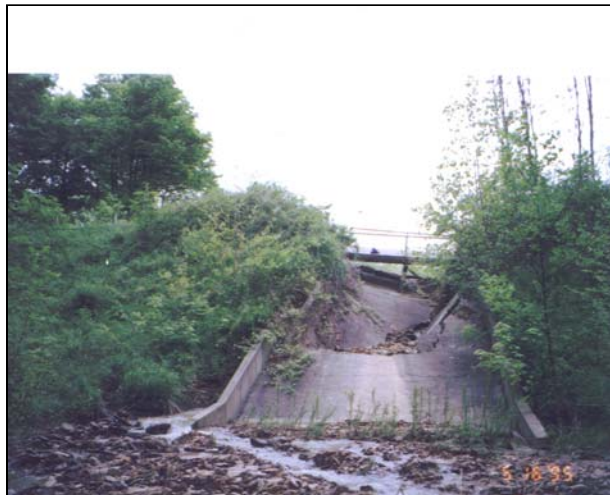
Figure 6-12 Serious structural damage requires replacement of spillway.

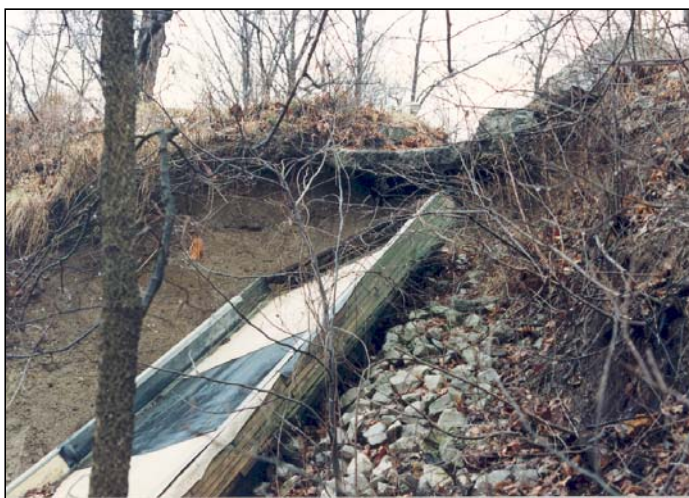
Figure 6-13 This concrete spillway was completely destroyed as a result of foundation erosion.

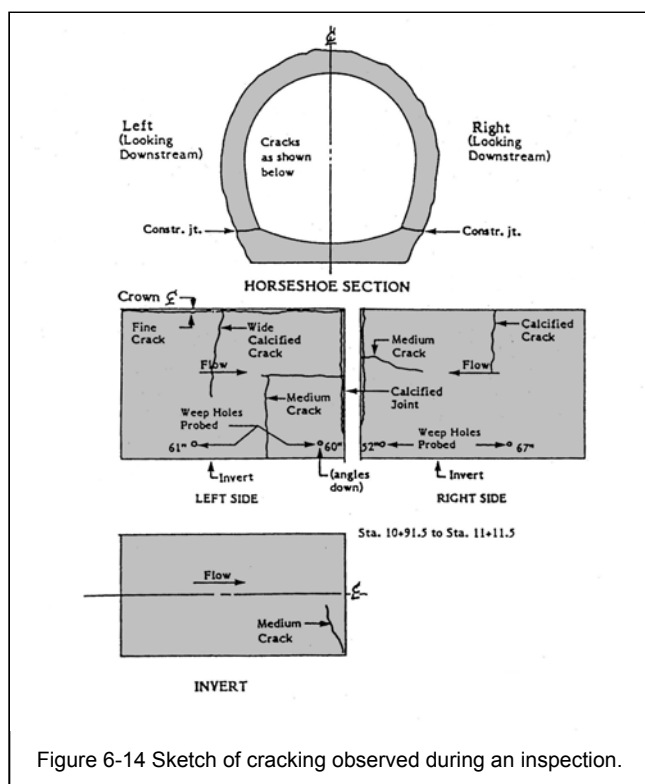
Figure 6-14 Sketch of cracking observed during an inspection.

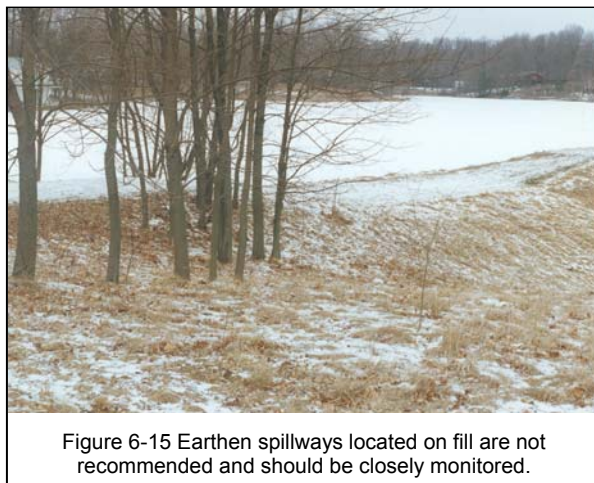
Figure 6-15 Earthen spillways located on fill are not recommended and should be closely monitored.

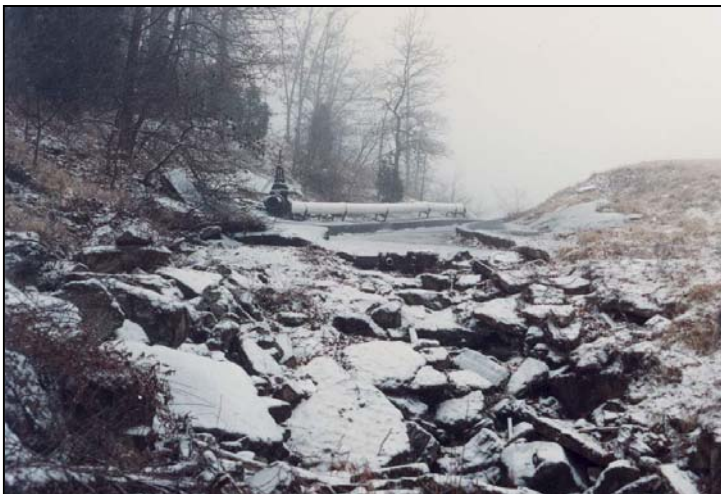
Figure 6-16 Poor spillway lining.

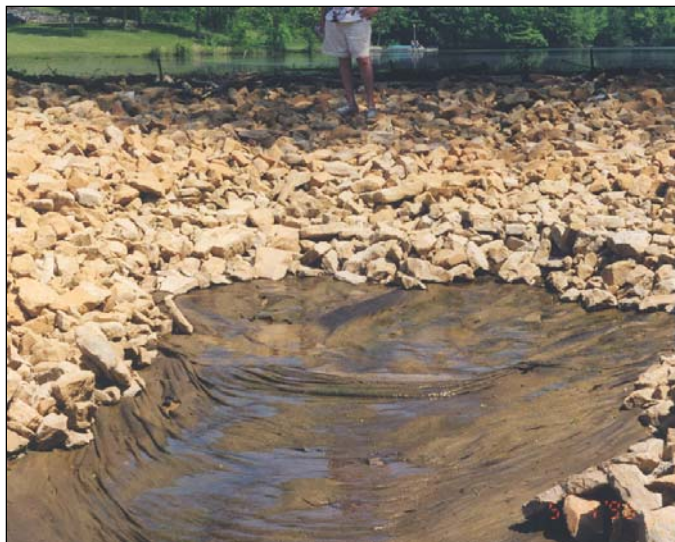
Figure 6-17 Riprap lining was completely washed away during a significant storm event, exposing the geotextile filter.

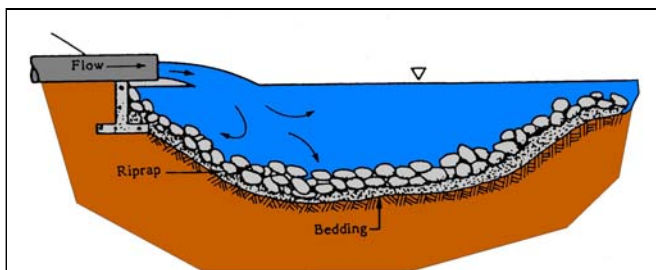
Figure 6-18 Typical rock-lined stilling basin at spillway outlet.

Stilling basins are often used at outlets to absorb the discharge energy. Stilling basins consist of a lined depression at the outlet of the spillway or outlet conduit. Stilling basins are commonly lined with riprap and a suitable bedding/filter material. Displaced riprap in stilling basins can result in

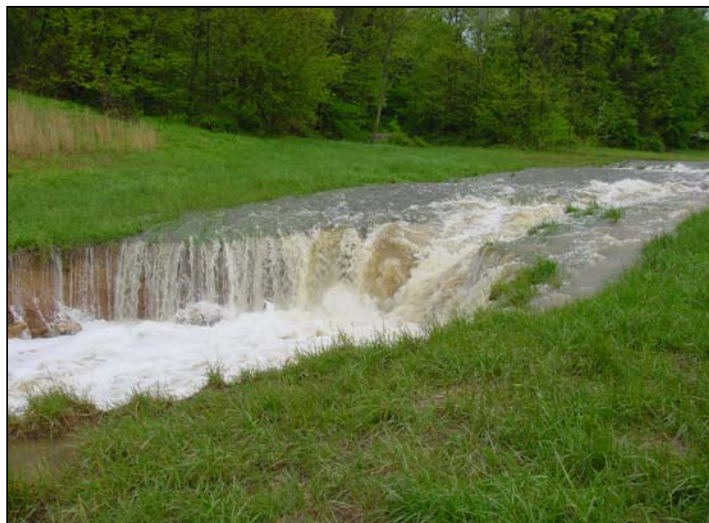
Figure 6-19 Grass lined outlet channel that was not designed for the flows it experienced, resulting in severe erosion.

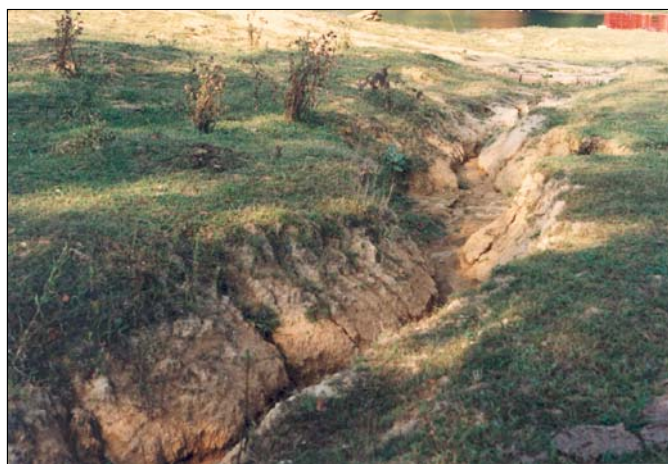
Figure 6-20 Severe gully erosion.

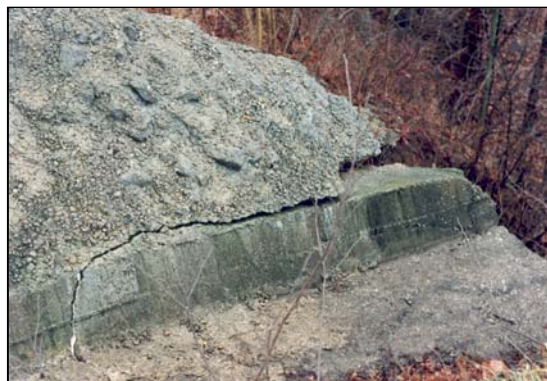
Figure 6-21 General deterioration of a concrete spillway as a result of multiple causes.

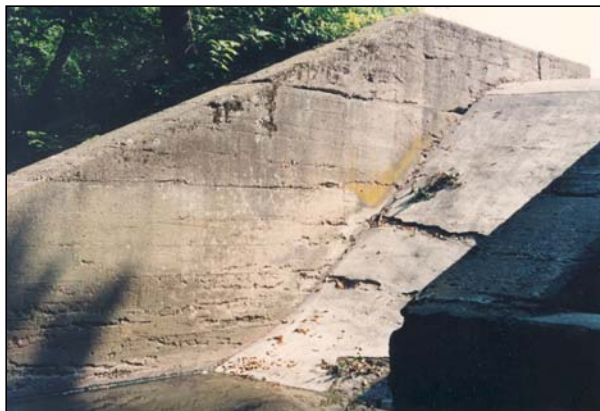
Figure 6-22 Deterioration (cracking and spalling) of a concrete spillway from weathering and freeze-thaw effects.

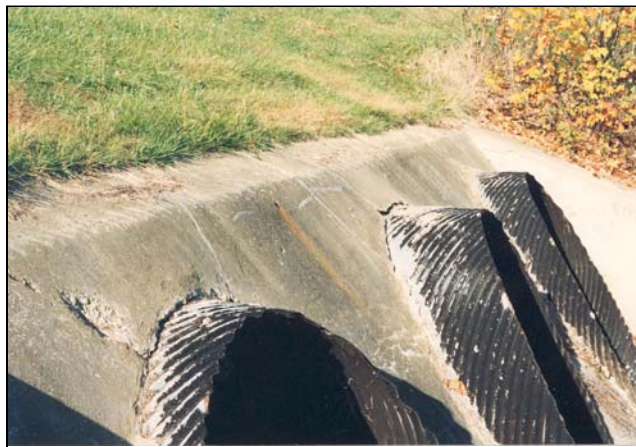
Figure 6-23 Concrete is deteriorating where these metal pipes enter a spillway riser as a result of differential expansion rates.

Many times concrete that is cast around corrugated spillway conduits creates problems due to differential expansion and contraction. The two different materials expand and contract at different rates which may result in cracks in the concrete. Another problem

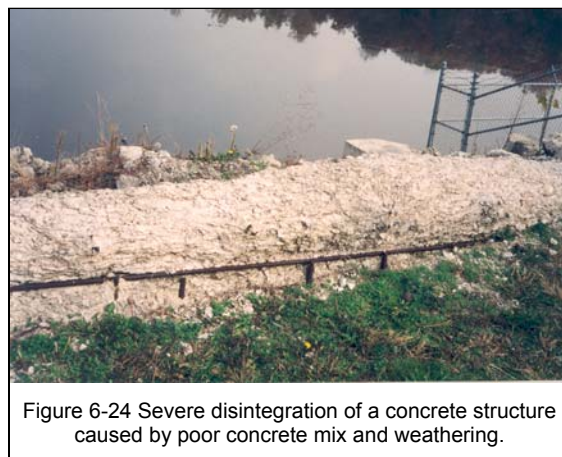
Figure 6-24 Severe disintegration of a concrete structure caused by poor concrete mix and weathering.

Large areas of crumbling (rotten) concrete, areas of deterioration which are more than about 3 to 4 inches deep (depending on the wall/slab thickness), and exposed rebar indicate serious concrete deterioration. If not repaired, this type of concrete deterioration may lead to structural instability of the concrete structure. A registered professional engineer should prepare plans and specifications for repair of serious concrete deterioration.

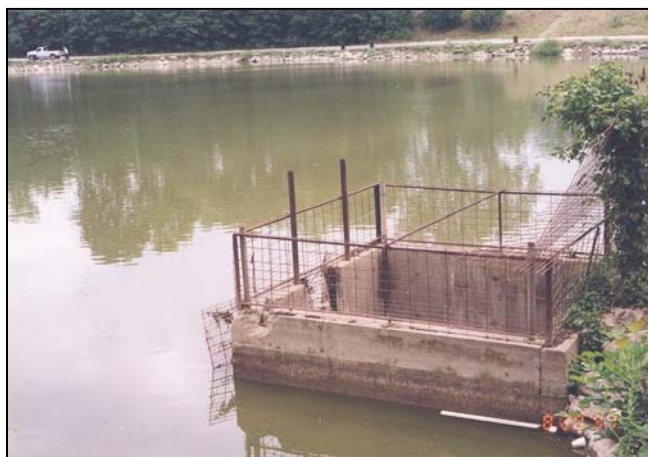
Figure 6-25 Concrete riser is spalling, exposing rebar and experiencing loss of concrete.

Spalling usually affects only the surface of the structure, so it is not ordinarily considered dangerous. However, if allowed to continue, spalling will cause structural damage, particularly if the structure is of thin cross section. Spalling often results in exposed reinforcing, leakage paths opened around embedded waterstops at joints, offsets on flow surfaces, and development of points of structural weakness. Repair is necessary when reinforcing becomes exposed

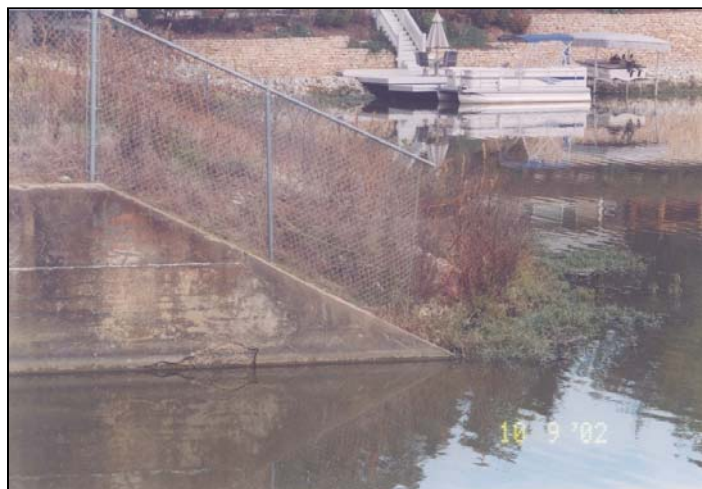
Figure 6-26 Side wall of spillway is spalling.

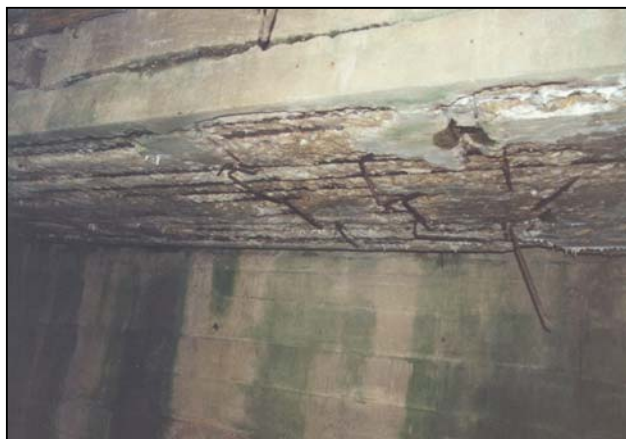
Figure 6-27 Rebar exposed from spalling is rusting.

Metal corrosion is the formation of iron oxide, or rust, when water (especially salt water) reaches steel in the concrete. It may also be corrosion of aluminum, if used, when water reaches aluminum embedded in or on the concrete. It is often caused by the use of deicing salts on bridge decks and similar structures that can cause corrosion without initial deterioration of concrete. Corrosion typically results in an increase in volume of the reinforcing metal that causes cracking and spalling of overlying concrete (mostly affecting thin structures). Typically, the bond is broken between the steel (or aluminum) and concrete, destroying the structural strength. Visible signs of metal corrosion include straight, uniform crack lines above reinforcing, rust stains on the surface, spalling, exposed reinforcing, and deterioration of concrete adjacent to unprotected aluminum fish ladders, hydraulic pumps, gates, and guardrails.

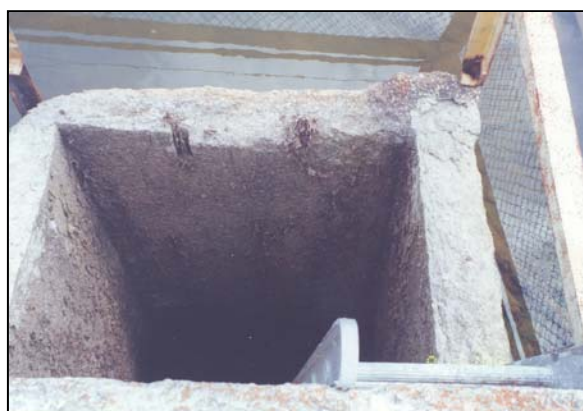
Figure 6-28 Erosion of concrete on top of riser.

Erosion of concrete is caused by fast-moving water containing abrasive material such as sand and gravel, debris, and ice. Ballmilling is a form of erosion which is the grinding away of a surface, usually in a circular pattern, especially in stilling basins. Erosion results in the wearing away of softer aggregates, or of the matrix material around the aggregates. The inspector should also look for abrasion erosion at points of abrupt change in flow channels or at corners, and the loss of concrete from the surface. Erosion in its worst form may result in severe destruction of concrete.

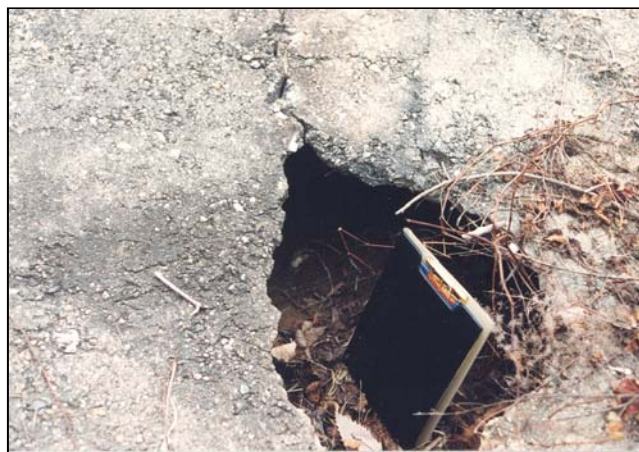
Figure 6-29 Erosion of foundation soil caused this concrete section to fail.

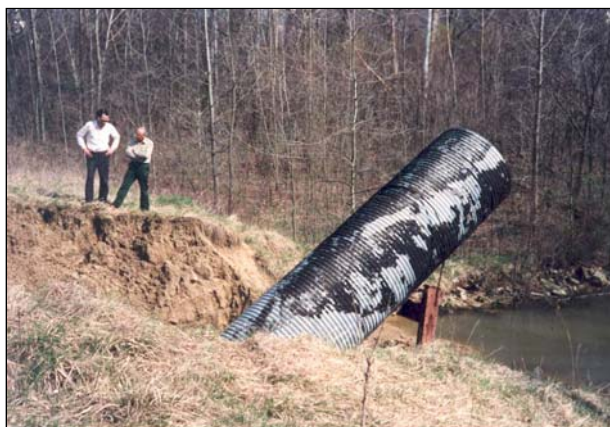
Figure 6-30 Soil erosion under this metal spillway caused the outlet end to settle, resulting in the inlet end tilting upward.

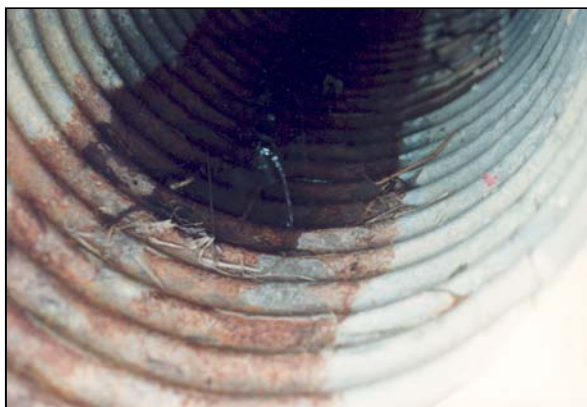
Figure 6-31 This corrugated spillway pipe rusted through, allowing seepage to enter the pipe.

Corrugated metal pipes that are used as spillway structures can have other serious problems besides corrosion. These problems are usually associated with installation practices, and include foundation or backfill erosion, and pipe buckling and crushing. These problems are usually caused by poor compaction in the haunching zone, poor compaction of backfill material beside and over the pipe, and heavy equipment traffic over the pipe. Because of these problems, corrugated metal pipes are not recommended for initial placement, upgrades, or replacements in any dam.

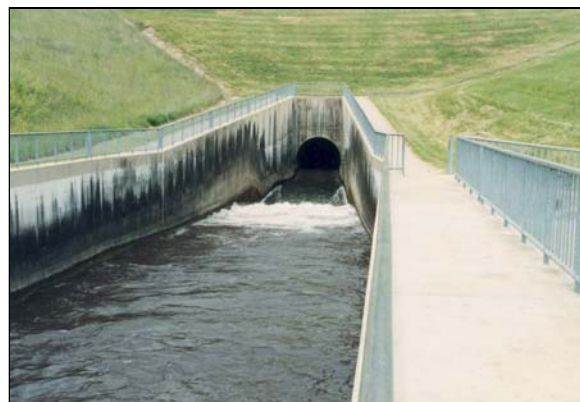
Figure 6-33 Inspecting a spillway that has flowing water is very difficult.

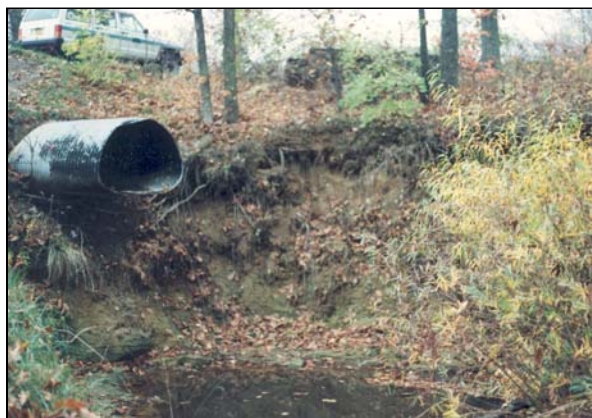
Figure 6-34 The outlet of this spillway has been undermined from the erosive forces of the discharge water.

Undermining is the removal of foundation material surrounding a conduit. Any low areas or unexplained settlement of the earthfill in line with the conduit may indicate that undermining has occurred within the embankment. As erosion continues, undermining of a conduit can lead to displacement and collapse of the pipe sections and cause sloughing, sliding or other forms of instability in the embankment. As the embankment is weakened, a complete failure of the conduit system and, eventually the dam may occur. Undermining along the entire length of conduit is referred to as piping.

In addition, undermining can occur as the result of erosion due to inadequate energy dissipation or inadequate erosion protection at the outlet. This undermining can be visually observed at the outlet of a pipe system and can extend well into the embankment. In this case, undermining can lead to other conduit problems such as misalignment, separated joints and pipe deterioration.

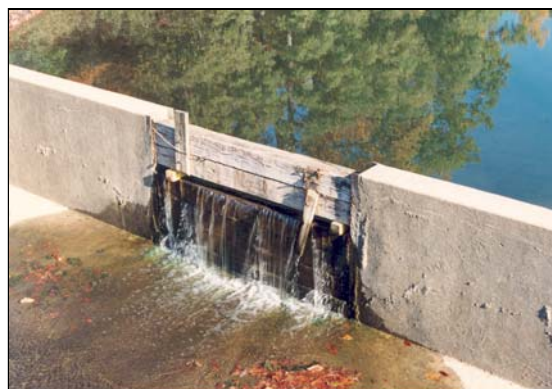
Figure 6-35 Wood flashboards exhibiting leakage.

Flashboards are usually wood boards installed in an upright position along the crest of the spillway to raise the normal pool level. Flashboards should not be installed or allowed unless professional investigation indicates there is sufficient freeboard remaining to safely pass the design flood. Some flashboard installations are designed to fail when subjected to a certain depth of flowing water, thereby recovering the original spillway capacity. However, flashboards designed to fail may not be reliable and are not recommended. Maintenance generally consists of repairing or replacing broken boards. The support structure for the flashboards should be examined for damage due to wear, misalignment, corrosion, and leakage, and repaired as necessary. The flashboards should be removed periodically (at least once a year) as a check for freedom of movement and deterioration of the boards. Leakage is a common problem. Unless there are extenuating circumstances, flashboards should be removed prior to the onset of flood season (typically March in Indiana) and reinstalled when conditions permit.

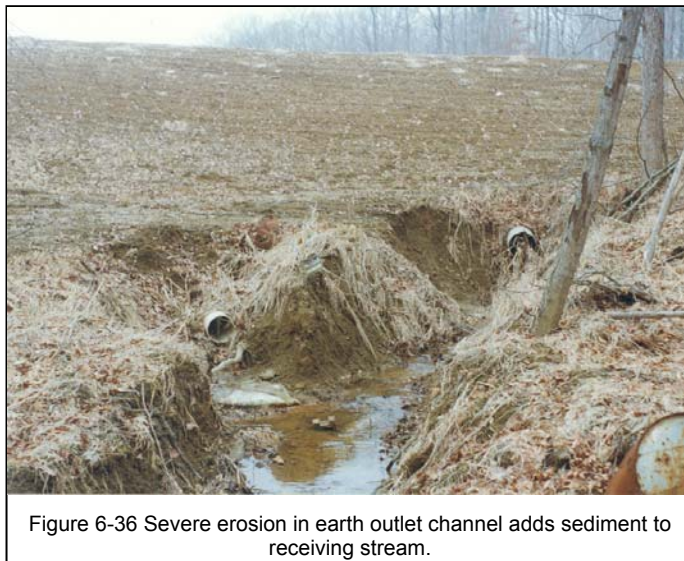
Figure 6-36 Severe erosion in earth outlet channel adds sediment to receiving stream.

If spillway side walls slide and block the spillway entrance or channel, the dam may become susceptible to overtopping because of reduced capacity to pass flood flows. Erosion of plunge pools and return channels may expose the toe of the dam to erosion, undercutting, and subsequent slope failure.

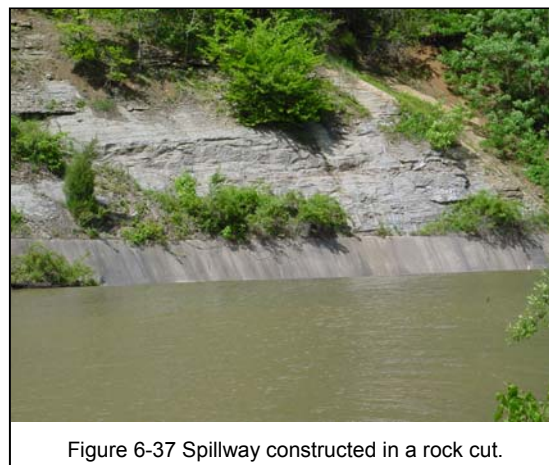
Figure 6-37 Spillway constructed in a rock cut.

Dams built in areas where rock is at or near the surface may include outlet works and spillway channels and tunnels constructed in or through the rock. Fallen rock may block discharges through a tunnel or channel, or rock falling into the reservoir immediately upstream from the dam could render outlet works, penstocks, or spillways inoperable. Abutment movement may restrict or prevent operation of appurtenances located in or on the abutment. Loosened rock could block or

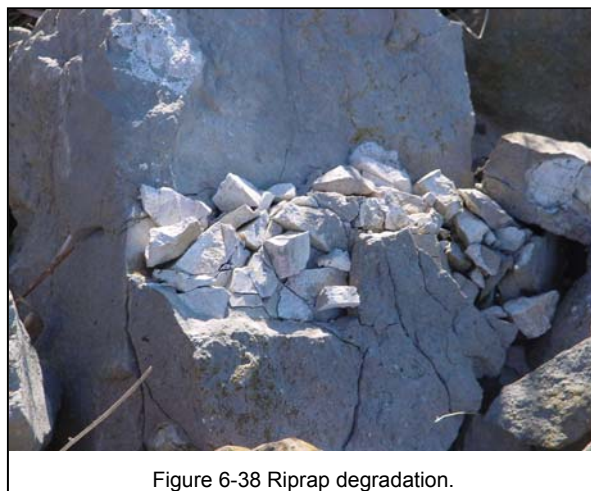
Figure 6-38 Riprap degradation.

Riprap may suffer from displacement or rock degradation. These deficiencies may be related, with degradation often leading to displacement.

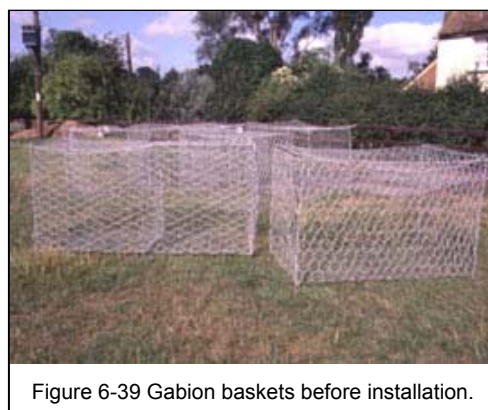
Figure 6-39 Gabion baskets before installation.

Gabions may be used as lining and support in spillways, stilling basins, and other dam outfall structures. A gabion is a prefabricated rectangular wire cage or basket filled in place with rocks. Gabions are free-draining and capable of being stacked for erosion protection. The term "gabion wall" may be used to refer to stacked gabions, while "gabion mattress" refers to a layer of gabions used to protect a chute or basin floor.

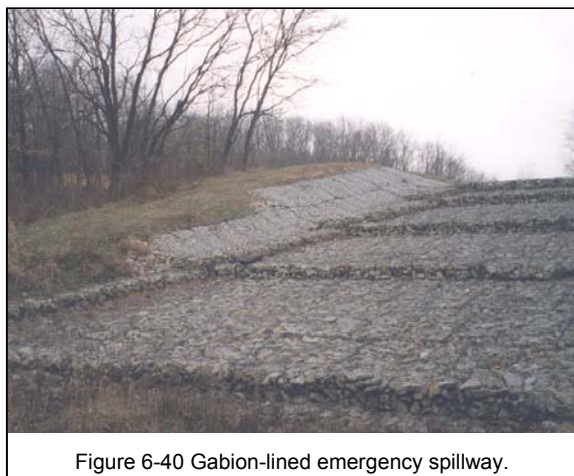
Figure 6-40 Gabion-lined emergency spillway.

Gabions are usually subject to various deficiencies that may cause deformation and possible toppling of gabion walls. These deficiencies include inadequate foundation support, foundation erosion, settlement of the rock within the basket, rock degradation, and failure of the wire baskets. Settlement and possible displacement of gabions can result from inadequate foundation support or from erosion of the subgrade. Foundation soils may be eroded when gabions are used because water flow can occur at the bottom of the basket. Proper foundation treatment is essential when gabions are
